The above and following photos were captured from videotape of crash tests performed on April 6-7, 1999. Two identical 1996 Ford Taurus GL models were used in these tests. One vehicle had original manufacturer hood and fender; one vehicle had a CAPA certified hood and left fender installed.

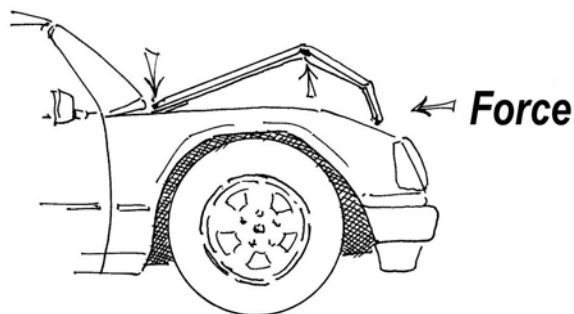
The first vehicle tested (pictured above) retained the original factory hood and fender. From these photos it appears that the hood performed as designed in that the hinge area (1) retained contact with the hinge plate and the hood "tented" (2) absorbing energy forward of this area.

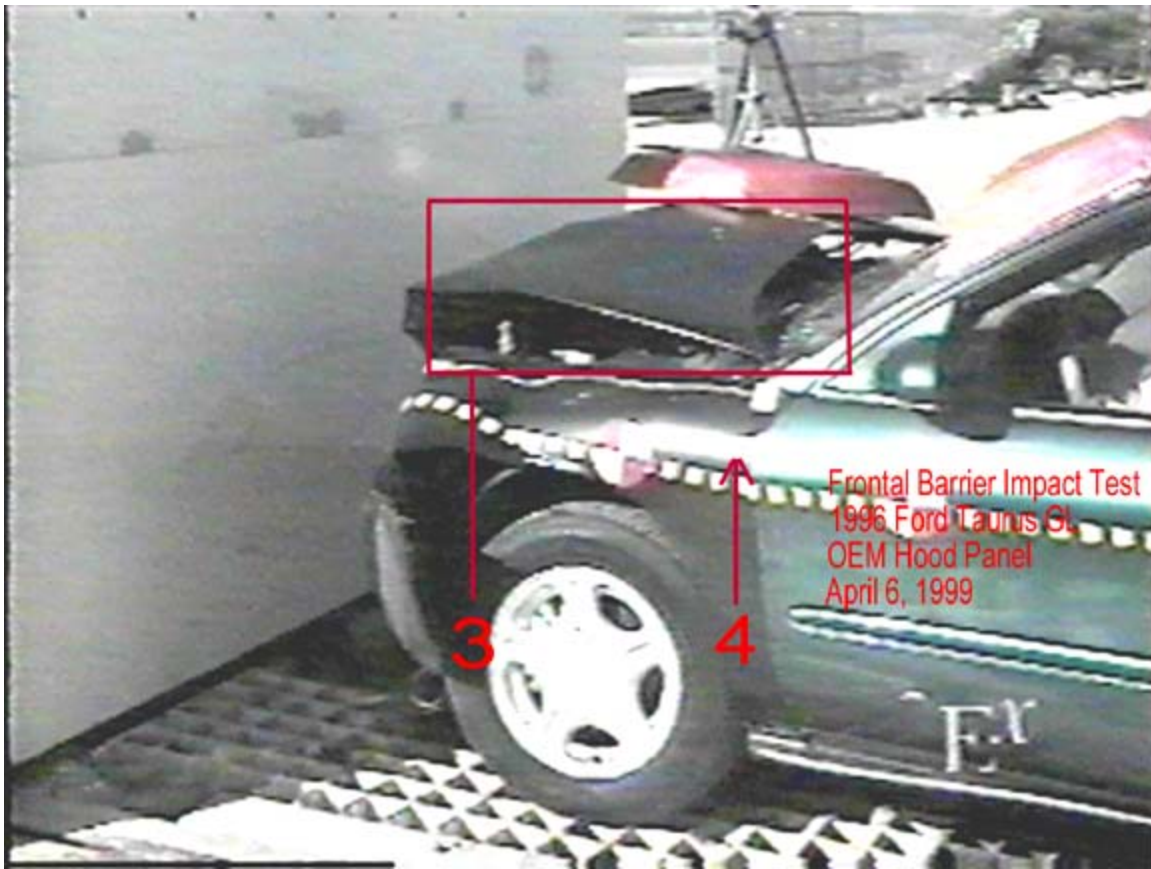
This photo is of the vehicle with OEM hood and left fender from the opposite side after impact. Note the sharp angles and relatively flat areas pictured (3), which indicate the factory designed “darts” performed as designed.

The left hinge area and rear fender (4) are consistent with the damage on the right side.
